## **REPAIR AND CONSERVATION WORKS ON TAGUS SUSPENSION BRIDGE**

José Paulo Costa<sup>a</sup>, António Couceiro<sup>b</sup> and Santinho Horta<sup>c</sup>

### **ABSTRACT**

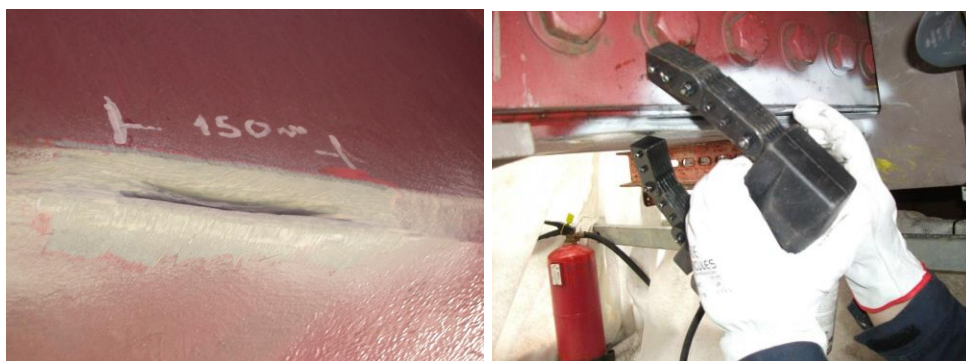
In certain zones of the rigidity metallic beam some seam welds were cracked. Those welds were reconstructed restoring its initial strength.

**Fig. 4 A seam weld prepared for welding after preparation of surface. Fig. 5 Magnetic particle testing after welding.**

The cracks were first cleaned with abrasive discs until the complete removal of the fissures (Fig. 4). Penetrating liquids and magnetic crack detection were used to confirm the absence of fissures in the parts to be welded. The seam welds were repaired through manual arc welding by certified welders, following certified procedure and welding specification. After execution, each welding was fully inspected and non destructive tests were done – penetrating liquids, magnetic crack detection (Fig. 5) and ultrasonic tests. After the supervisor's approval, protective anti-corrosive coatings were applied.

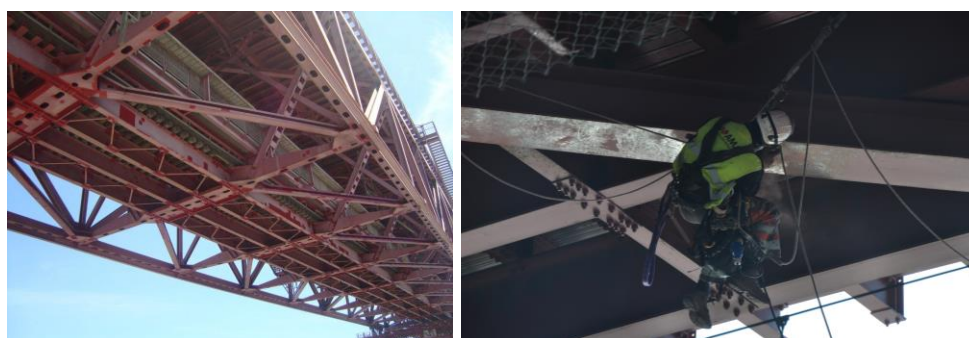
In some areas of the different elements that form the rigidity beam (nacelles of the inferior level, diagonal inferior bracings between stringers, superior transverse beams, railway deck stringers, etc.) the existing coating was damaged. The protective coating of those zones was restored through the application of a polyurethane based material.

**Fig. 6,7 Anti-corrosive coating of the steel rigidity beam.**

Prior to the application of the coating system, the surfaces of the damaged areas were prepared and cleaned. The preparation of the surfaces was done with an electric grinder or manual brush until a ST3 grade was achieved. The coating system was then applied in accordance with the supplier's specifications and instructions.

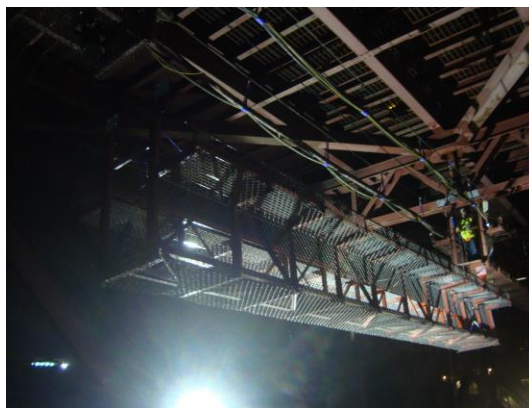
The central walkway, that is used to permit the access of teams for inspection of the structure that supports the road way, was replaced due to its bad conservation condition. The central walkway also includes the supporting mat for the infrastructure cables that cross the river and the galvanized wire netting that encases the walkway.

**Fig. 8** Night installation works of the new modules of the central inspection walkway.

The assembly of the modules of the new central inspection walkway was always done at night (Fig. 8) during the periods without the passage of trains (Refer and Fertagus). During these works, the high voltage energy in the catenary had to be cut off.

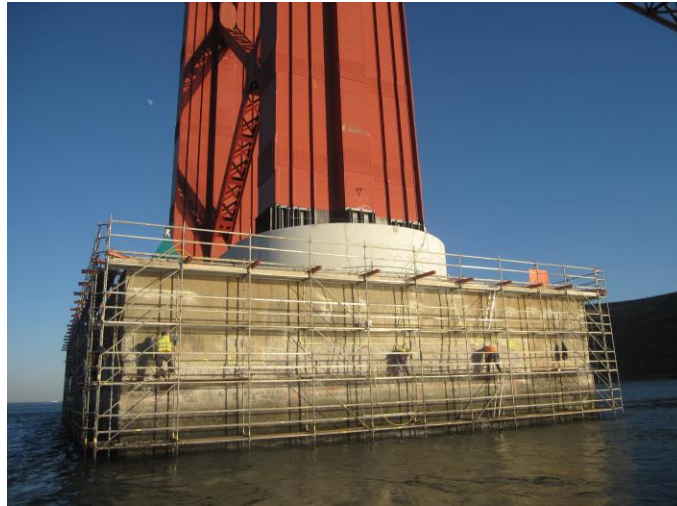
Main difficulties associated with these works were due to its location in the river (Fig. 9) so that all of the equipment and materials necessary for the execution of the techniques had to be transported by boat as well as the supplying of water and energy.

**Fig. 9 Scaffolds for the south tower concrete repair works.**

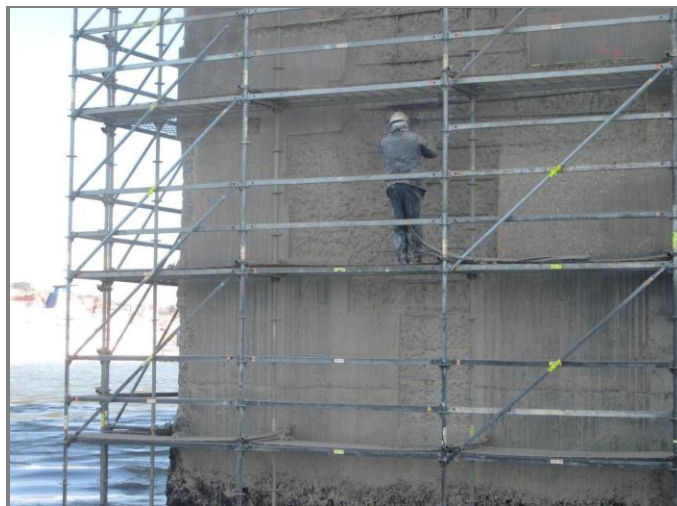
**Fig. 10 Sprayed concrete restoration of reinforced concrete.**

Sprayed concrete proved to be a very effective technique for the repair of reinforced concrete. Sprayed concrete is a method of placing concrete at a high velocity and does not require formworks (Fig. 10). Because the concrete is installed at a high velocity, it will have a higher density than conventional concrete in most cases. The increased density will provide reduced permeability and higher durability. Sprayed concrete brings out a resistant and durable material, which has excellent adhesion characteristics to older concrete and reinforcement.

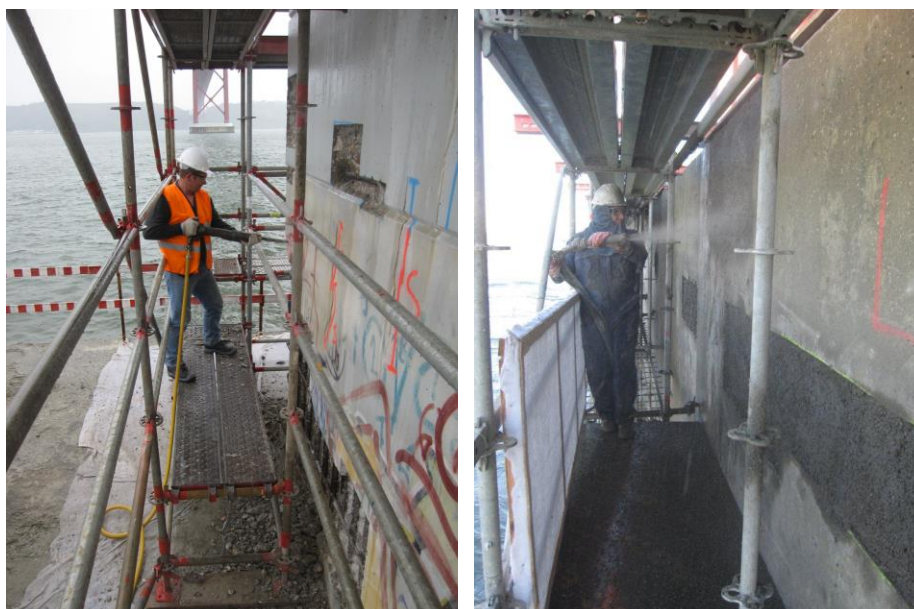
**Fig. 11 Preparation of concrete surfaces. Fig. 12 Reconstruction of sections using sprayed concrete.**

Application of sprayed concrete followed a sequence of required procedures. Surface preparation corresponds to the critical starting operation. All weak, loose and damaged concrete was totally removed through hammers and sand blasting (Fig.11, 13). The objective was to create a clean and sound surface with the proper surface roughness to receive the sprayed concrete.

The dry cement based mixture was blown through the hose to the nozzle, where the water is injected immediately prior to application. Mixing is completed as the material impacts on the receiving surface, through manipulation of the nozzle (Fig. 12, 14). This requires a very highly skilled nozzleman, especially in the case of thick or heavily reinforced sections. The nozzleman's goal is to achieve adequate compaction and envelopment of the steel reinforcement.

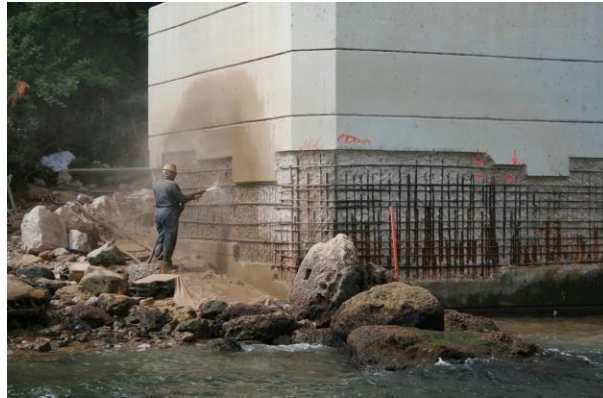
**Fig. 13 Sandblasting preparation of damaged concrete surfaces.**

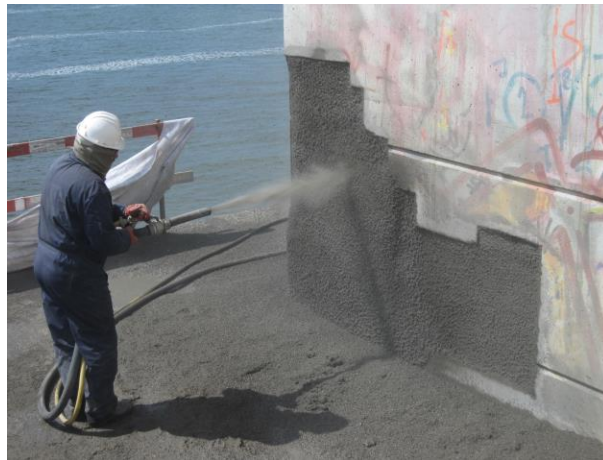
**Fig. 14 Concrete repair by sprayed concrete.**

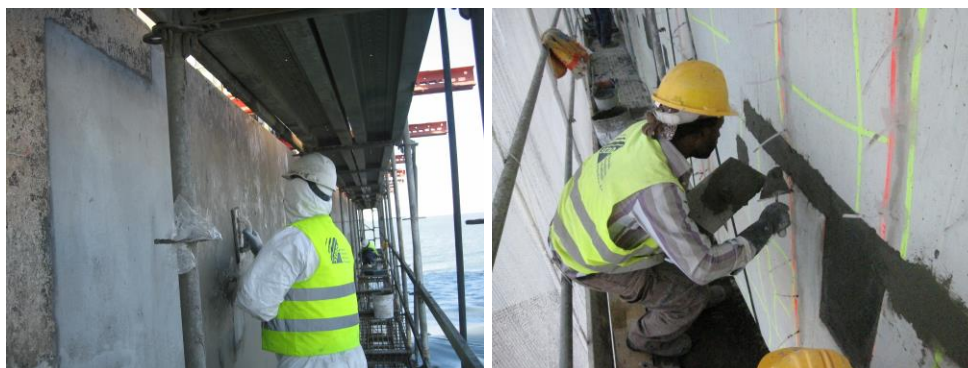
**Fig. 15, 16 Hand applied mortar repair of reinforced concrete.**

Minor surface areas of damaged concrete were reconstituted using repair mortars which were manually applied. The mortars were pre-batched cement based, with controlled shrinkage and appropriate strength properties. The mortars were applied and compacted into the prepared substrate taking special care to avoid inclusion of entrapped air pockets

and making sure the reinforcement was completely wrapped thus protected against corrosion (Fig. 15, 16).

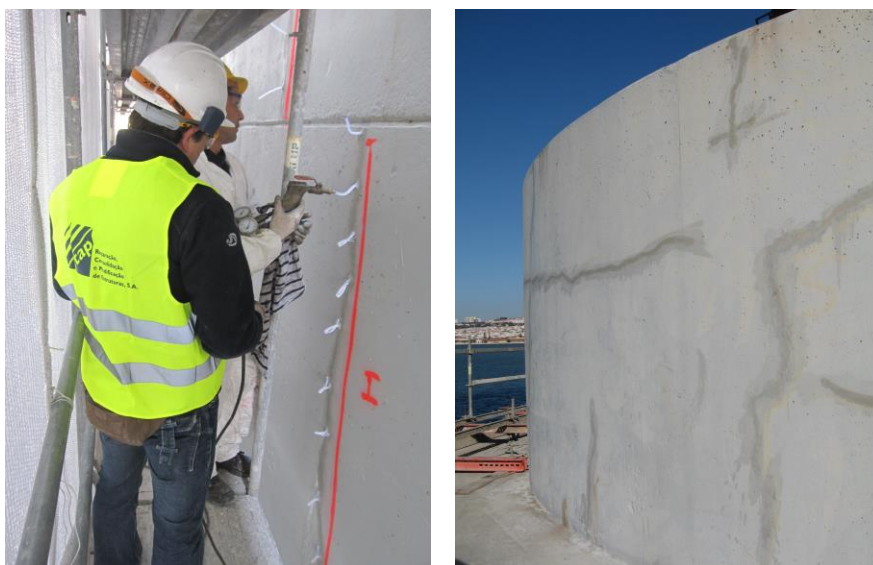
**Fig. 17, 18 Concrete injection of cracks.**

Another technique used to repair concrete was the treatment of cracks that was used to restore material integrity and avoid harmful consequences of voids and cracks in concrete like the penetration of aggressive agents that might induce corrosion of steel reinforcement. The low viscosity resins are injected into cracks and when cured form a durable, structural bond-seal with a compressive strength exceeding the strength of the concrete.

The basic steps of the injection process were: cleaning the surface for crack exposure; installation of injection ports (ports are typically placed at 13cm to 20cm spacing, with increased spacing on wider cracks); surface sealing with an epoxy based material to contain the injected resin in the crack (the entire exposed crack is covered with the paste, leaving only the port holes uncovered); injection of the cracks and removal of the ports. The injection usually begins at the lowest port (from the bottom up) and continues until the resin begins to exit through the adjacent port. That's the visual sign that the crack has been filled to that level. The port is then capped and the process is repeated moving on to the next port along the crack (Fig. 17). After all of the ports are injected, adequate time for the epoxy resin to completely cure was allowed. Following cure, the ports and the sealing were removed by cutting or grinding.

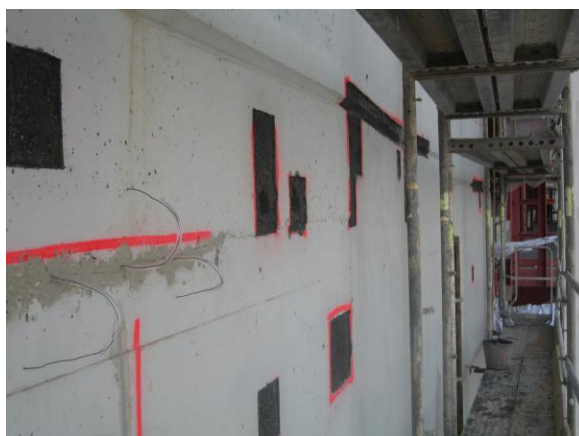
**Fig. 19 Hand applied mortar concrete repair and treatment of cracks.**

All surfaces became then ready for the application of intended aesthetic results (Fig. 19). Figure 20 shows cleaning of surfaces before receiving final paints.

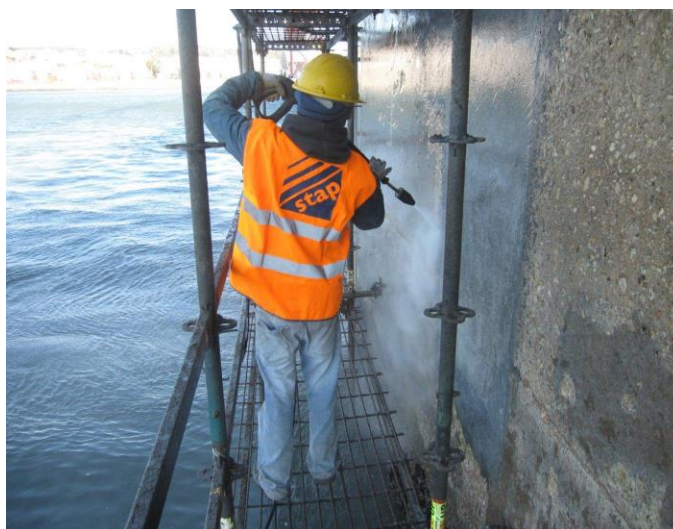
**Fig. 20 Preparation of surfaces for the application of final coating system.**

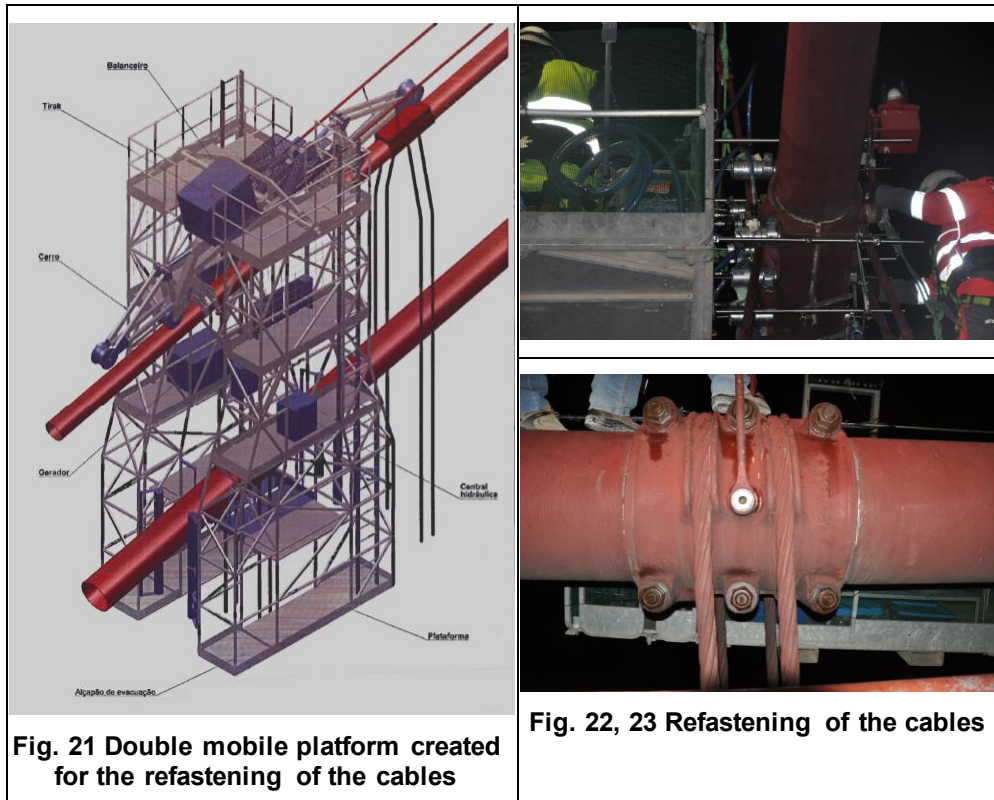
Re-fastening of the bolts of the braces that fix the principal and secondary suspension cables was done with specific hydraulic tensioners up to a previously calculated stress. The hangers (vertical cables) are fixed on the braces. The braces cannot slide along the cables and this is avoided by checking the tightness of all bolts existing on the braces. For each tensioning operation, a report is done indicating the sequence of the tensioned bolts, the measurements and the hydraulic pressure. After completion of the tensioning procedures, a silicon sealant was applied on the joints of the braces and their protective anti-corrosion coating was restored.

For the operation of re-fastening of the bolts, it was necessary to design and build a double mobile platform that moved along each cable and was fixed next to each brace (Fig. 21, 22, 23). Due to the relative position of the two cables (principal and secondary), one above the other, and the existence of the vertical cables with regular spacing, the platform for the two cables was a unique device system that was only supported by the superior cable. The conceived platform comprised a tubular profiles rigid structure and a set of operative mechanisms.

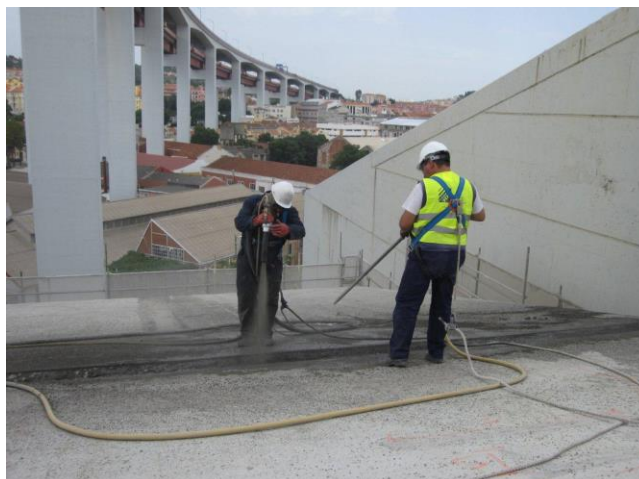
**Fig. 24 North anchorage block restoration by sprayed concrete.**

In the north central block (the original older one), shotcrete was applied to rehabilitate the exterior face of the coverage of the block as shown in Figure 24. Other works related to the anchorage blocks were waterproofing of the coverage of the south anchorage block, repair of the drainage system, replacement of stairs and platforms and installation of protection devices. Regarding the south anchorage block, repair of concrete was achieved through hand applied mortar and crack injection of interior and exterior surfaces (Fig. 25, 26).

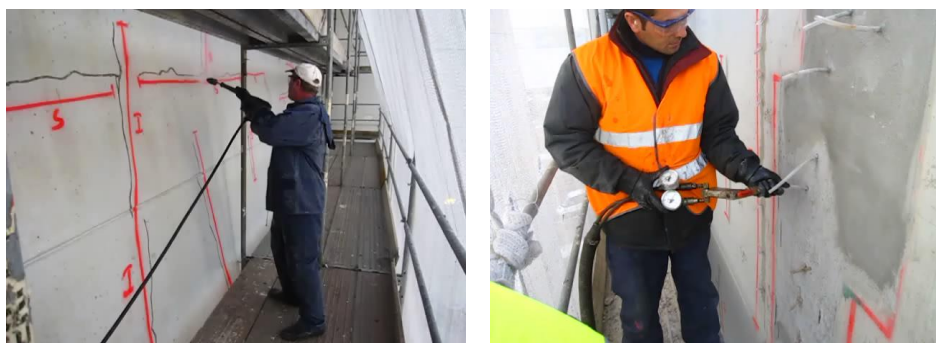
**Fig. 25, 26 Treatment of concrete cracks. Concrete injection.**

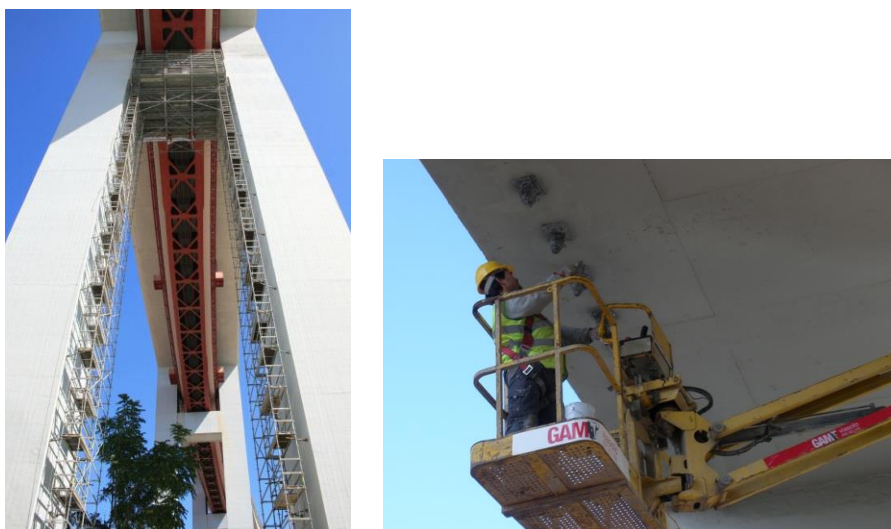
**Fig. 27** View of the scaffolds for the repair works. **Fig. 28** Repair of the anticorrosive protection of the anchors.

Crack injection and hand applied mortar were the selected techniques to rehabilitate the reinforced concrete of the north viaduct columns and cantilevers (Fig. 27). Other relevant work was the repair of the anticorrosive protection of the anchors of the vertical pre-stress of the transverse decks (Fig. 28).
