Structural Rehabilitation of a Chloride Contaminated Concrete Silo From View Point of Durability

Cóias e Silva, Vítor
Costa, José Paulo

Synopsis

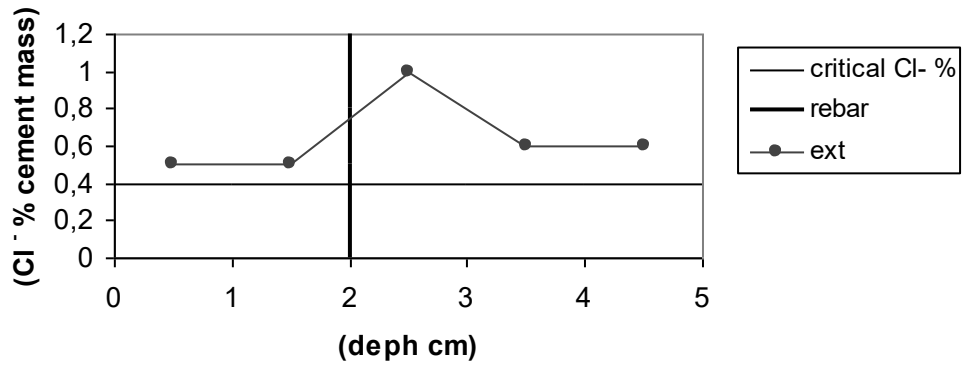
Chart 1 - Chloride profile external surface

Chloride content is high in the cement mass, 0,6% to 1% of cement mass at reinforcement depth (chart 1). Taking into account the results of the determination of chloride content at different depths, it was concluded that the high chloride content obtained on the external side is mainly due to the diffusion of the air-borne chlorides of the salt-saturated marine environment.
