"AWARD OF EXCELLENCE 2009"

A slipformed reinforced concrete silo for grain and foodstuffs was built in 1980 and rehabilitated in 1999 in the Azores Islands. Due to design and construction deficiencies, the structure showed significant degradation. Faced with the low durability of the piecemeal repairs carried out to cope with concrete spalling due to corrosion, the owner decided to adopt a thorough approach, which began with an accurate diagnosis, to support a suitable strategy for the full rehabilitation of the structure.

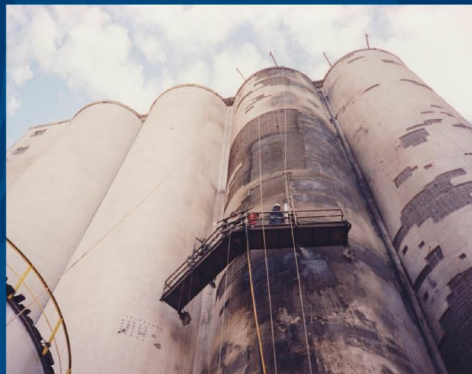
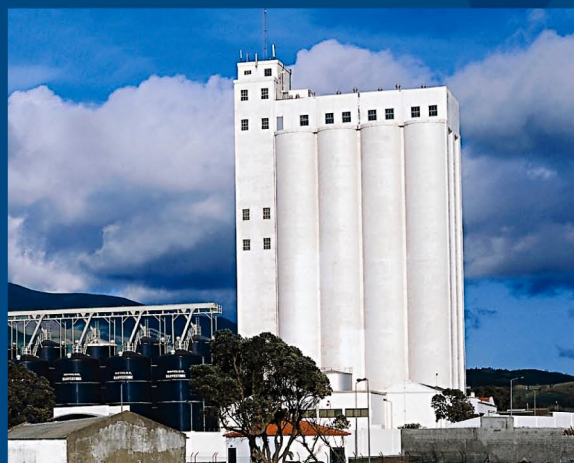
A detailed inspection involving nondestructive testing was conducted. The concrete was found to have high chloride content due to the exposure to marine environment. Several possible intervention strategies were made available to the owner (which included demolishing the existing silo and constructing a new one). The selected rehabilitation strategy involved the repair of anodic zones using sprayed concrete, application of migrating corrosion inhibitors, and total external protection through a coating against carbonation and chloride penetration. A quality plan was implemented during the repair work, including control of supplies and repair processes, and inspection and testing during the work and on the final product. A monitoring system was designed and installed to assess the post-repair behavior of the silo, consisting of a number of sensors embedded in the silo walls. According to data obtained up to the present, the rehabilitated silo is performing fairly well. This case study shows the importance of close cooperation between owner, designer, and contractor, and following the proper methodology when dealing with structural rehabilitation projects.
