Cathodic Protection of concrete structures: a case study of Madeira airport.

Abstract. Reinforced concrete structures located near the coast are particularly prone to corrosion due to the presence of chloride ions in the air surrounding the structures. This article presents a practical case study of the implementation of cathodic protection (CP) to a 4,000 m² area reinforced concrete structure near Madeira International Airport, Portugal. This paper describes the corrosion condition of the columns and arcades, based on a 2018 inspection report by the regional civil engineering laboratory (LREC) and highlights the key aspects of the design, the installation and the construction works as well as the first-year monitoring results of the cathodic protection system. These results demonstrate that the application of cathodic protection (CP) is an effective solution for mitigating corrosion and extending the service life of this structure.

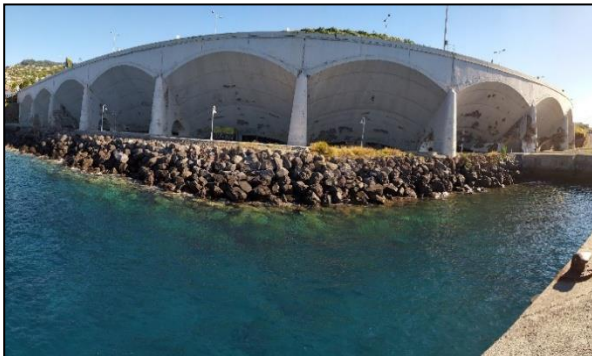
This structure was built to support the regional highway at Madeira International airport, and it is critical for the airport's operational safety. This concrete structure with 10 arcades and 11 columns was designed by Edgar Cardoso and Hidroservice, Engenharia de Projetos, and it was originally built in 1979 (Figure 1).

Figure 1 – Front view of the infrastructure.

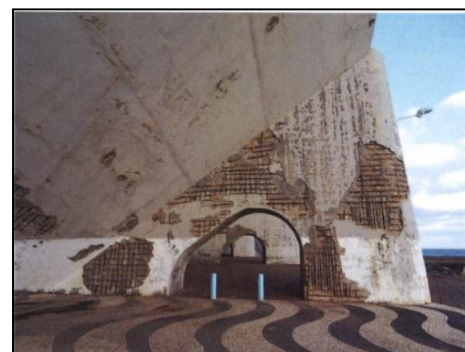
The chloride content at the reinforcement level (30-50mm), varied between a minimum of 0.56% (arcade 8) and a maximum of 2.5% (arcade 10). Thus, these values far exceeded the corrosion initiation threshold which indicated that corrosion is actively propagating throughout the structure, leading to substantial and visible damage, particularly to the columns. (Figure 3).

Figure 3 – Pre-existing damage in the columns [1].

The inspection highlighted extensive delamination exceeding 50% in the columns while the arcades showed a delamination area below 10% (Figure 4 and Figure 5).

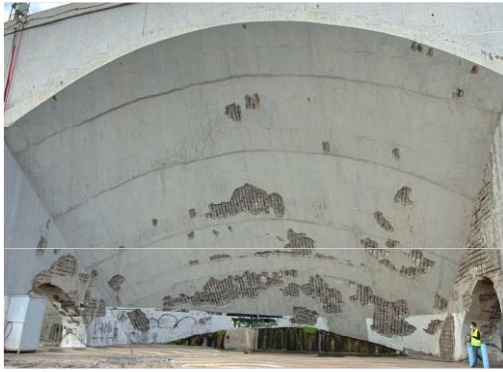
Figure 4 – Condition of Arcade 7 before intervention [1].

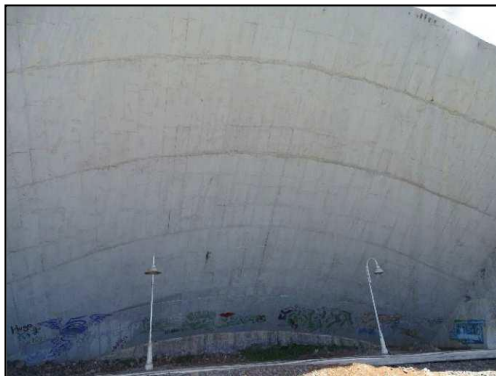
Figure 5 – Condition of Arcade 3 before intervention [1].

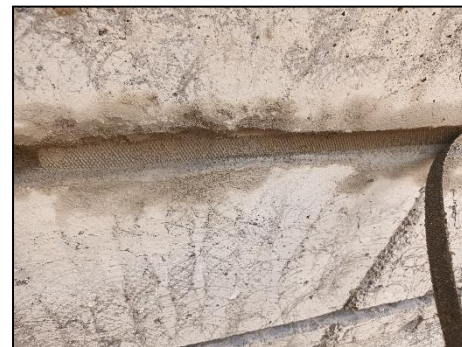
Figure 7 – Anode installation.

The mesh ribbon installation was made in the following steps: first, the slot was filled with a mortar layer; then, the titanium ribbon was installed (Figure 7); and, finally, another mortar layer was applied.

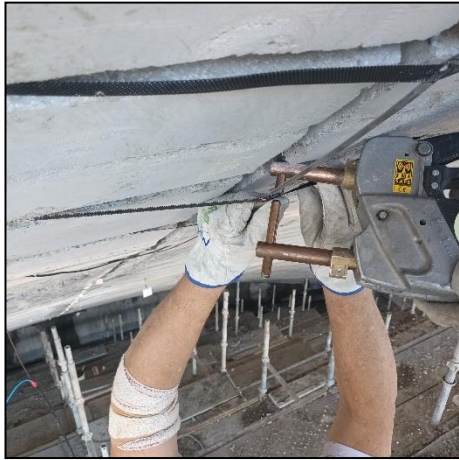
Figure 8 – Spot welding for anode ribbons.

Through spot welding, the Ti/MMO mesh ribbons and current distributor ribbons were connected (Figure 8).

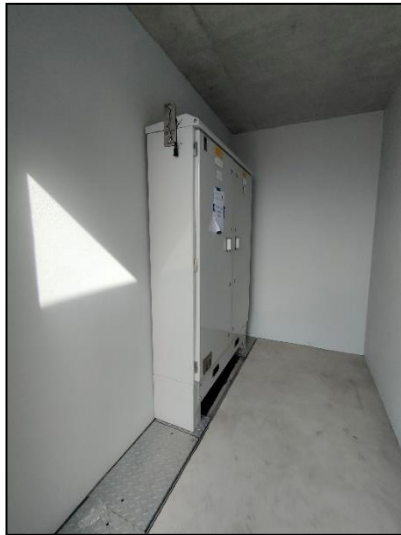
Figure 9 – Power supply unit.

Figure 10 – Power supply unit.

Finally, the power supply and monitoring unit were installed in a housing built for that purpose (Figure 9 and Figure 10). This unit provides the direct current required for protection and allows the remote control and monitoring of the system.
